**ONYX Home Inspections LLC.**  
3835 S Moore St  
Lakewood CO 80235  
303-594-1353  
onyxhomeinspections.com ONYX Home Inspections LLC.

**Inspection reference: 1014**

**Confidential Inspection Report**  
**3835 S Moore St**  
**Lakewood CO 80235**

**November 14, 2017**

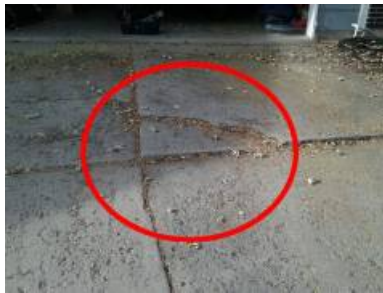
*Driveway:* OK MM RR  
   Cracks noted are major. Substantial cracks were observed on the driveway. Repairs are recommended to prevent further deterioration. Surface raised/settled, Spalling noted, Tripping hazards.

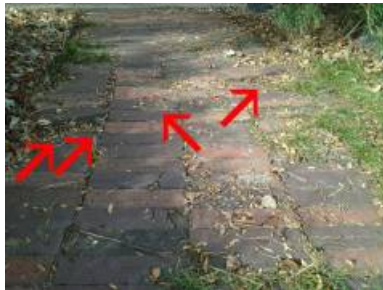
*Walks:*    Sidewalk type: Brick, Surface raised/settled, Tripping hazards.

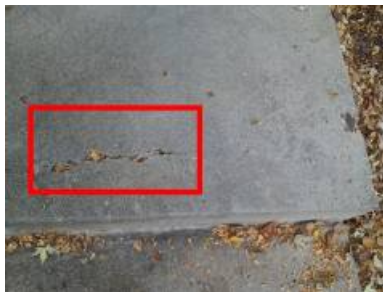
*Exterior Steps / Stoops:*    There is some minor concrete cracking and spalling on the front steps. Monitor and repair as needed.

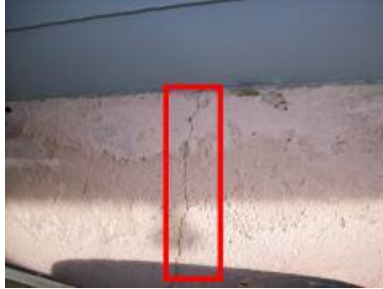
*Slab:*    Patio type: Concrete. . Concrete surfaces are prone to cracking from shrinkage and settling. Cracks noted - typical. The concrete patio slab exhibits minor cracking. Monitor and repair as needed.

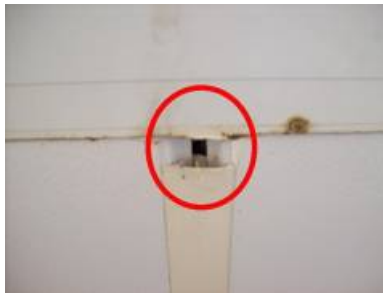
Sunroom attached to back of house. There is some damage to the outside of the sunroom under the gutter support. This should be repaired to prevent further damage and to prevent the possibility of bees nesting in the opening.

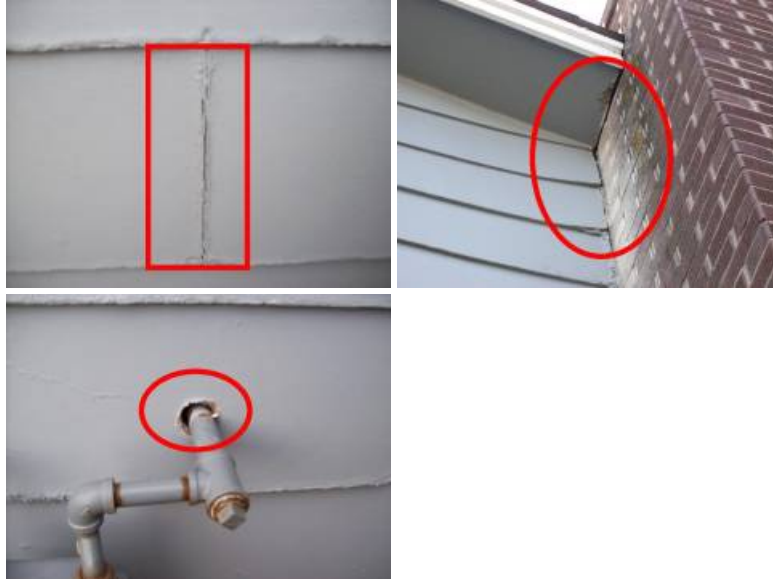
| <input type="checkbox"/> | <input checked="" type="checkbox"/> | <input type="checkbox"/> | <input type="checkbox"/> | , Walls are constructed with Hardboard siding. Cracks noted are typical, Damaged areas of siding are seen but can be easily repaired with a sealant. Monitor and repair to prevent further damage. |
| <input type="checkbox"/> | <input type="checkbox"/> | <input checked="" type="checkbox"/> | <input type="checkbox"/> | The siding is pulling away from the chimney leaving a gap between the house and brick fireplace which is a possible sign of settlement .Repair is needed to prevent moisture and or insects from penetrating the home. |
| <input type="checkbox"/> | <input checked="" type="checkbox"/> | <input type="checkbox"/> | <input type="checkbox"/> | Gaps in the exterior wall finish were not properly sealed at the gas or electric service A/C lines. Sealing these openings may prevent air, water, or insect entry. |

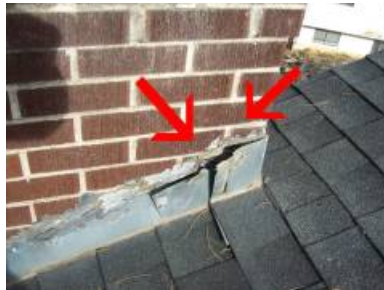
**Attention Needed** - The flashing as installed does not appear to be adequate, due to deterioration of the metal. Repairs are needed .

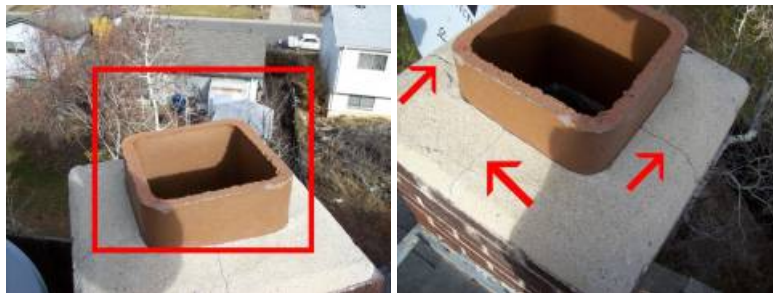
There is a chimney cap. The chimney cap is made of mortar. Its function is to keep water from entering the stack and causing deterioration. There is no metal rain hat installed. It is recommended that one be installed to help prevent rain from entering the flue stack.

The chimney cap has some cracking and should be monitored for further deterioration. There is no metal rain hat installed. It is recommended that one be installed to help prevent rain from entering the flue stack.

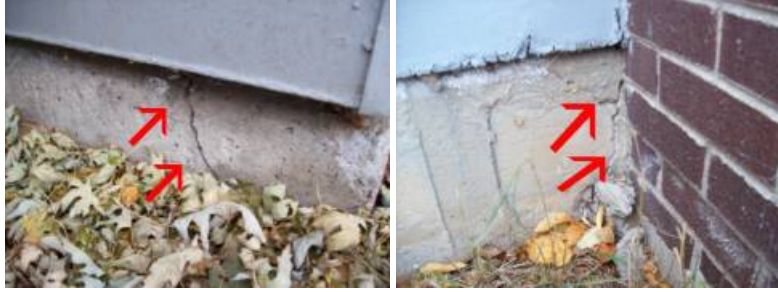
There is some typical cracking in some areas of the foundation around the outside of the house. These cracks should be repaired or at least monitored to prevent further damage.

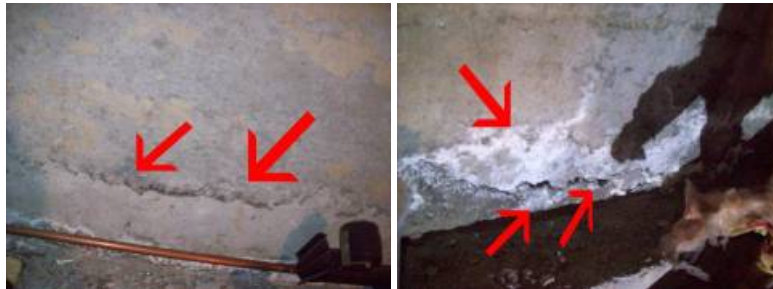
| <i>Walls:</i> | <input type="checkbox"/> | <input type="checkbox"/> | <input checked="" type="checkbox"/> | There are horizontal cracks on the crawlspace wall. These are not a major issue at this time but should be monitored and or repaired to prevent further deterioration. I recommend a licensed foundation engineer evaluate the cracks in the near future. |
| | <input type="checkbox"/> | <input type="checkbox"/> | <input checked="" type="checkbox"/> | There is effloresce on the foundation wall in the crawlspace. Efflorescence is the dissolved salts deposited on the surface of a porous material such as concrete or brick that are visible by a white chalky powder after the evaporation of water. The substance alone does not pose a major problem, but it can be an indication of moisture intrusion, which may compromise the structural material. |

| <i>Moisture:</i> | <input type="checkbox"/> | <input type="checkbox"/> | <input checked="" type="checkbox"/> | Staining was observed: Efflorescence seen on walls indicates the presence of periodic moisture. |

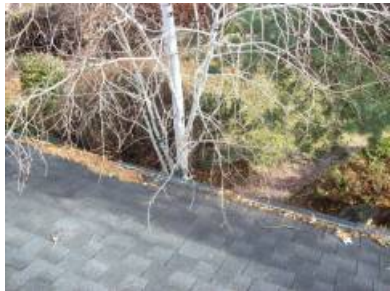
*Style:* Gable.  
*Roof Access:* Walked on roof.  
*Roof Covering:* OK MM RR  
   Composition shingles, Architectural heavy duty design.  
*Roof Covering Condition:* Appears serviceable, Tree limbs are contacting the roof surface and should be trimmed.

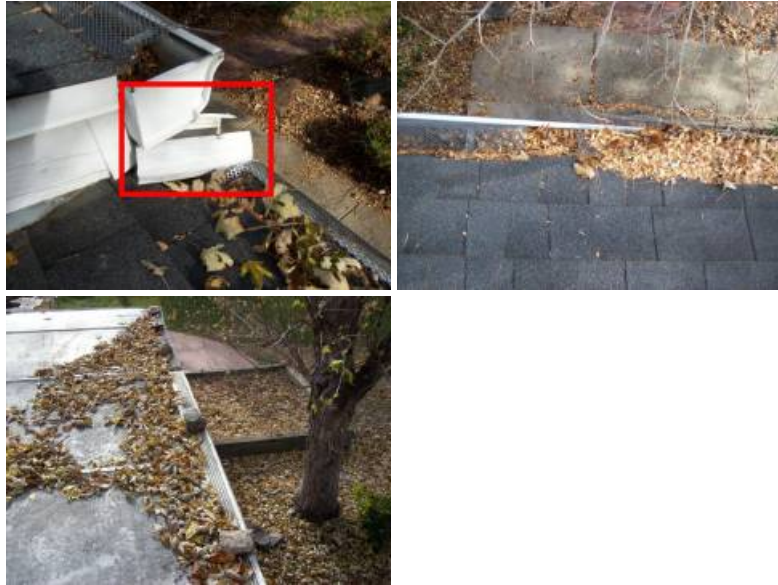
*Type & Condition:*    Gutters and downspout materials are aluminum. Building is fully guttered, Damage/Defects, Debris in gutter.

The gutters on the sunroom are covered with screens to help keep debris out. The screens are held in place with rocks and not directly attached to the gutters. This poses a safety hazard and should be addressed.

Gutters should be free of debris.

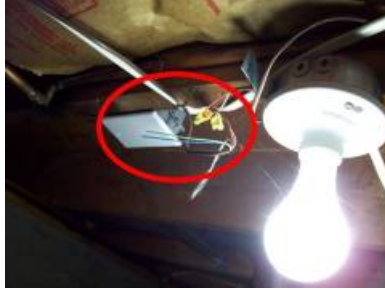
*Crawlspace:* Unprotected electrical wiring on the bottom of joists is susceptible to damage and should be protected by a rigid conduit.

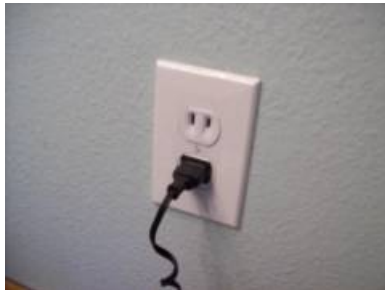
A representative sampling of switches and outlets was tested. As a whole, outlets and switches throughout the room are in serviceable condition. Ground Fault Circuit Interrupter (GFCI) outlets are recommended for installation at exterior, garage, bath rooms & kitchen outlets. This the master bathroom outlet . Two prong type.

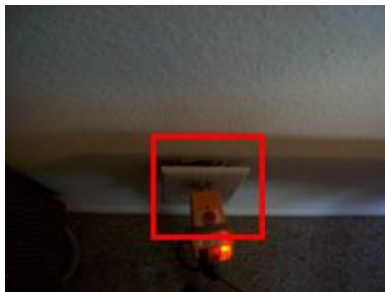
A representative sampling of switches and outlets was tested. At least one or more outlets needs attention by a licensed electrician.

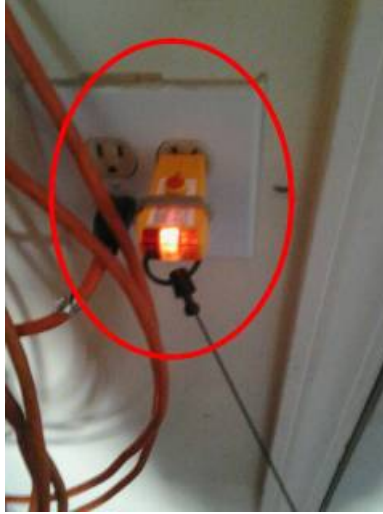
One or more outlets in the garage has an open ground.

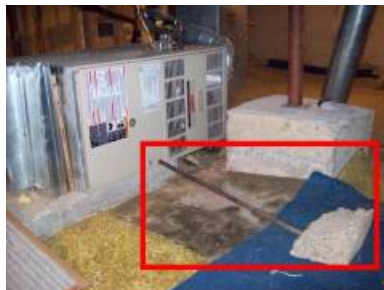
OK	MM	RR	
	<input type="checkbox"/>	<input type="checkbox"/>	<input checked="" type="checkbox"/>	Unit was operational at the time of inspection. Ill fitting access panels are noted. The access panel for the furnace is being held closed by a rock and a metal rod. Further evaluation by a licensed HVAC professional recommended.

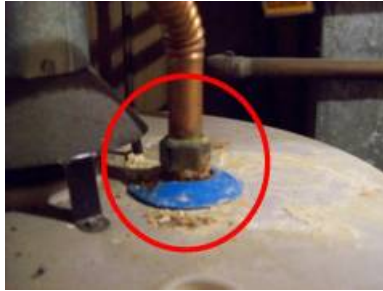
*Condition:* OK MM RR  
   There is some corrosion on the supply line of the water heater. I  
recommend it be further evaluated by a licensed plumber. Pressure  
relief valve noted, not tested.

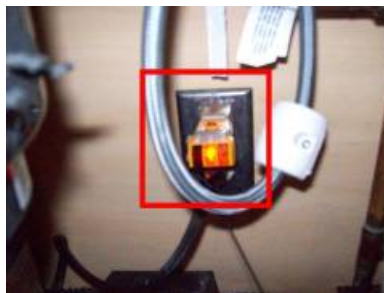
<i>Garbage Disposal:</i>	OK	MM	RR	
	<input type="checkbox"/>	<input type="checkbox"/>	<input checked="" type="checkbox"/>	Garbage disposal outlet has a open ground. Recommend be evaluated by a licensed electrician.

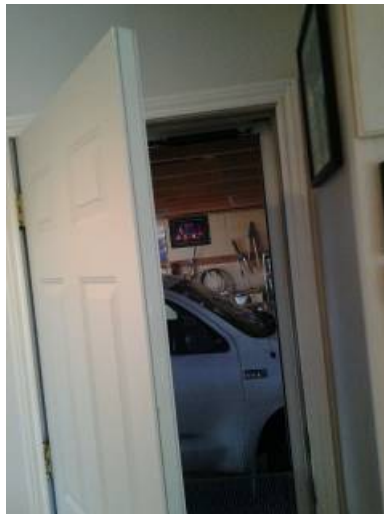
The fire rated door is not self closing.

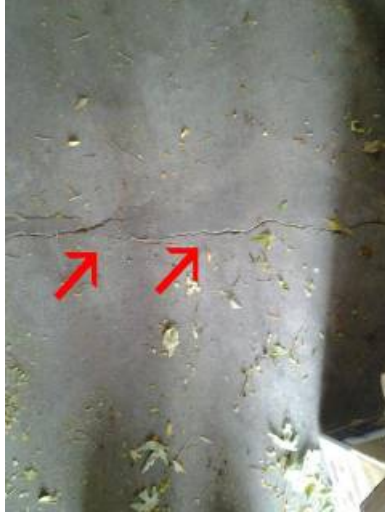
Typical cracks noted.
