**ONYX Home Inspections LLC.**  
3835 S Moore St  
Lakewood CO 80235  
303-594-1353  
onyxhomeinspections.com ONYX Home Inspections LLC.

**Inspection reference: 1014**

**Confidential Inspection Report**  
**3835 S Moore St**  
**Lakewood CO 80235**

**November 14, 2017**

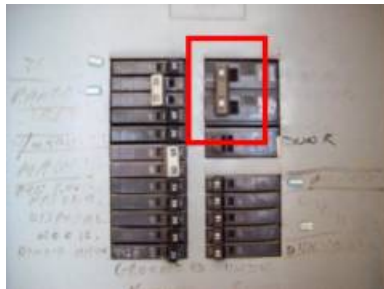
**Electrical Distribution Panels:**

<i>Main Panel Location:</i>	<input checked="" type="checkbox"/>	<input type="checkbox"/>	<input type="checkbox"/>	The main panel location is in the sunroom.
<i>Main Circuit Rating:</i>	100 amps.			
<i>Entrance Cable Size:</i>	1/0 Aluminum.			
<i>Service Disconnect Switch:</i>	Located at the top of main panel.

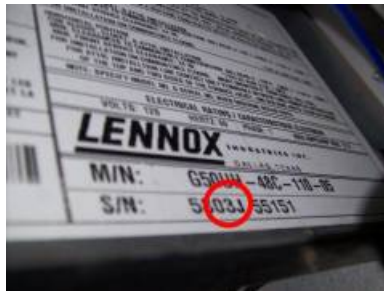
**Heating Equipment:**

*Type & Location:* Forced Air. Location- Crawlspace.  
*Fuel Source:* Natural Gas.  
*Capacity / Approx. Age:* Mid efficiency furnace. Approximate age of furnace is determined by serial number . In this case September , 2003 makes unit 14years old.

OK	MM	RR	
	<input type="checkbox"/>	<input type="checkbox"/>	<input checked="" type="checkbox"/>	Unit was operational at the time of inspection. Ill fitting access panels are noted. The access panel for the furnace is being held closed by a rock and a metal rod. Further evaluation by a licensed HVAC professional recommended.

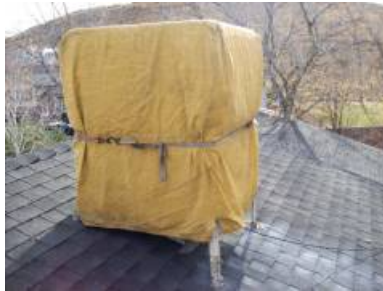
Swamp Cooler:    The house has a swamp cooler. Not inspected do to being covered.

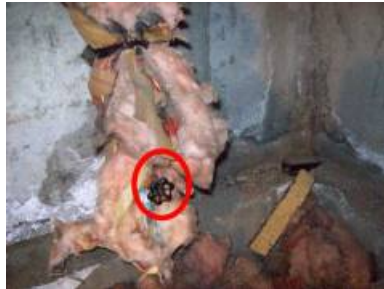
*Shut Off:*

Main shutoff valve is located, at the east side of the house.
